Urban runoff quality in the river Sowe catchment

Hyde, Michael

Award date:
2006

Awarding institution:
Coventry University

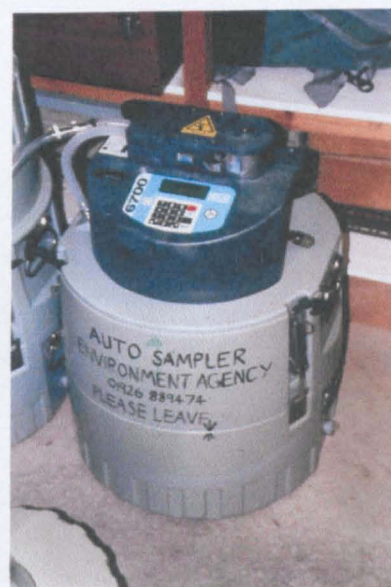
Figure 4.11: ISCO automatic sampler

An ISCO 6700 sampler (Figure 4.11 and 4.12) was used to take spot samples of the midstream water for analysis. Samples were taken as hourly composites at 15minute intervals over a period of 24 hours for each run.

Hourly spot samples taken for total ammonia (ammonium) determination (ISCO auto-sampler, Figure 4.11) assisted in considering these objectives, but also acted as a comparison with continuously monitored results to determine the accuracy of obtained data, and identify pollutant concentrations below detectable levels for laboratory analysis. These factors, along with a consideration of the benefits (or otherwise), of increased data collection, achieved by continuous monitoring over hourly automated or monthly manual sampling, are discussed in Chapter 8. The automated sampling also allowed detection of other pollutants, such as SS and phosphate, which were not measured by the continuous monitors.

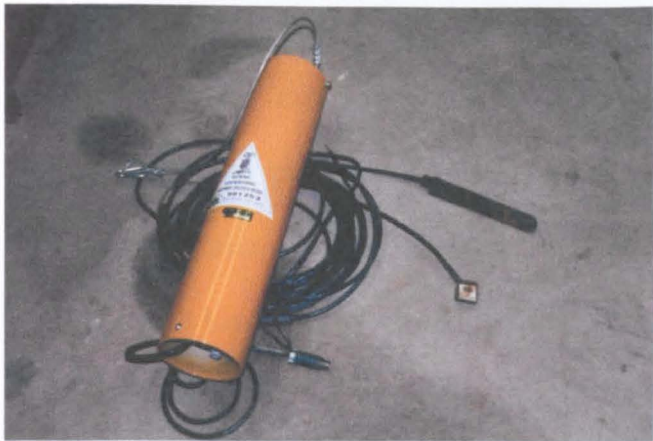
Figure 4.13 Rocky Mountain Industries (RMI) flow monitor

The flow monitor used at Humber Avenue was a Rocky Mountain Instruments (RMI) Flowrat 1000, which is a solid-state electronic device with depth and velocity capability, as shown in Figures 4.13 and 4.14:

Continuous quality monitors were placed in the River Sherbourne at Meadow Street (upstream of the City Centre), and at Humber Avenue downstream of the City (see Figures 4.15 to 4.19). A Rocky Mountain Industries (RMI) continuous flow-recording device (see Figures 4.13 and 4.14) was deployed at Humber Avenue and stage boards were installed at both sites. Stage board data from Kingsbury Road and Whitley were obtained from the Environment Agency. Spot samples were taken at one-hourly intervals for a 24-hour period during some storm events, and analysed for comparison with continuous data. Samples were analysed for BOD, suspended solids, ortho-phosphate, total phosphate, ammonia, pH, and heavy metals (total zinc, cadmium, copper, chromium, nickel and lead).

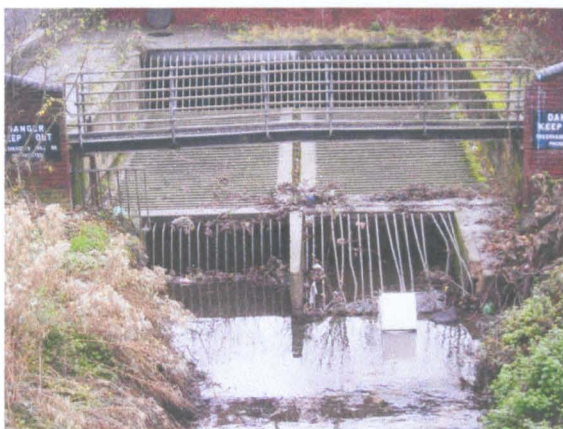
a) Beginning of the culverted section

Figure 4.16 (a-d) Monitoring and sampling equipment in situ at Meadow Street

The results considered in this section relate to the investigation of a storm event between 15 and 17 March 2001, recorded at Meadow Street and Humber Avenue in Coventry, using local rainfall measured at Coventry STW (Finham), and measured flow from Humber Avenue, as discussed in Section 4.5. Water quality data were obtained using an ISCO 6700 automatic sampler (Figures 4.11 and 4.12) collecting hourly composites, at 15-minute sampling intervals, at the Humber Avenue site only (Figure 4.18). YSI 6920 continuous water quality monitors (Figure 4.2 to 4.4) were used at Meadow Street and Humber Avenue, to obtain continuous water quality data for upstream and downstream of the culverted section of the River Sherbourne. The equipment was installed as shown in Figures 4.16 to 4.19.

- 1) Diurnal variation in pH, DO and temperature will be recorded. Total P levels in the watercourse, (arising from rural sources and numerous small sewage treatment plants upstream of the catchment) are very high ($300\text{--}500\mu\text{g l}^{-1}$), and the algal activity in the watercourse is pronounced, particularly at the upstream monitoring point, after the open section of watercourse. (Figure 4.16).

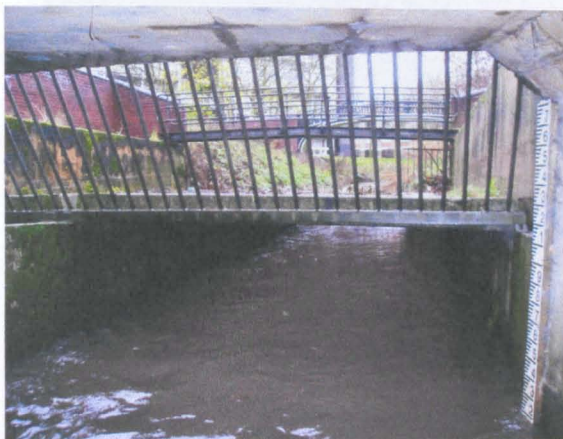
a) upstream of monitoring point

Figure 4.17(a-b) River Sherbourne culvert upstream and downstream of Meadow Street

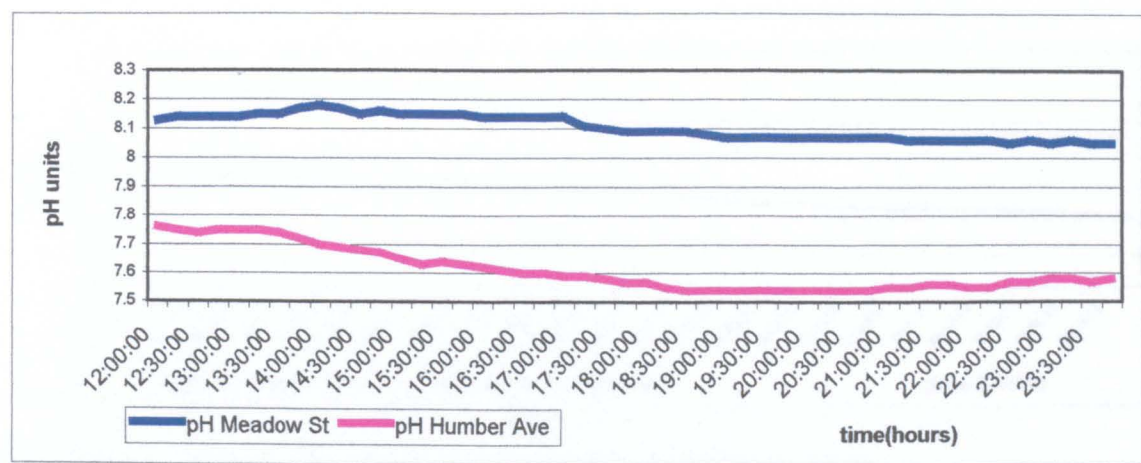
Figure 7.15 Continuous monitoring– pH September 2003

The pH results showed a slight diurnal variation with levels consistently higher at Meadow Street than at Humber Avenue. The fluctuation recorded was <2 pH units over the monitoring period, as shown in Figure 7.15. The pH values were within acceptable limits (6.0-9.0), as required by all relevant legislation applicable to the watercourse.
